# IMAGE ARTIFACTS

Artifacts are image appearances that do not represent the true anatomy being scanned. Artifacts occur due to a variety of reasons in particular:

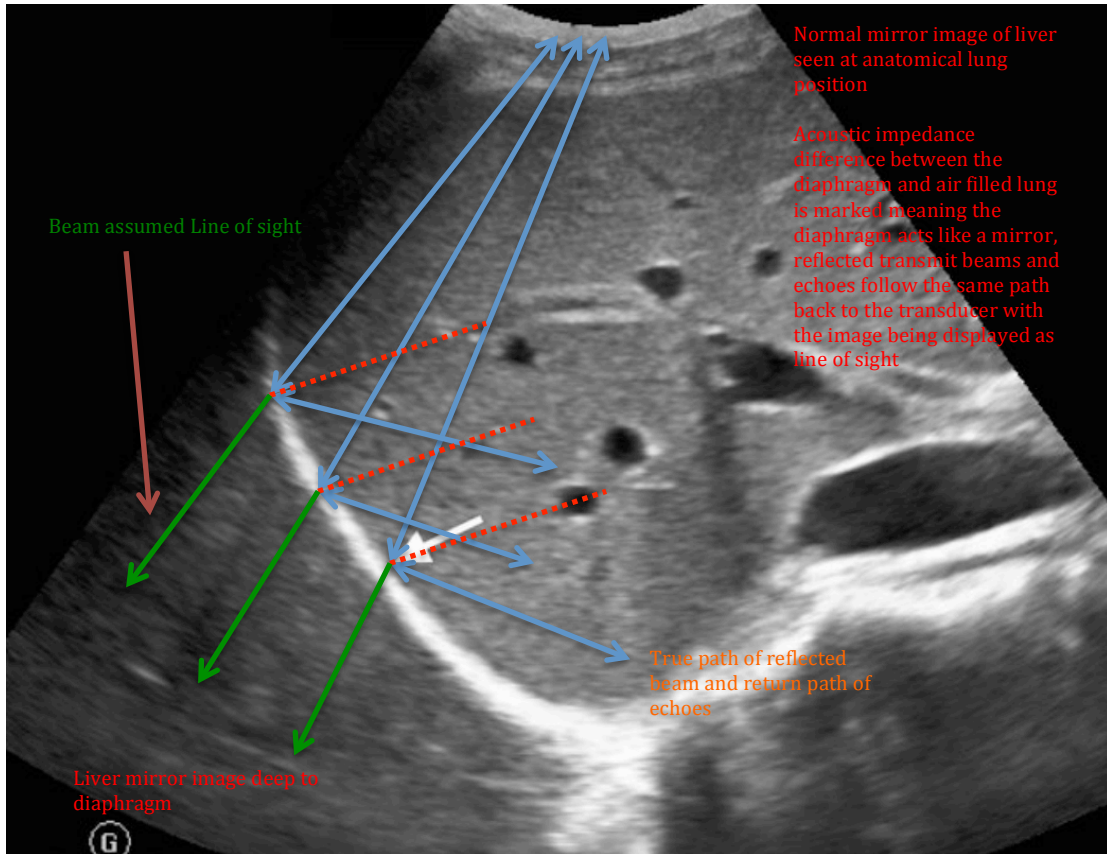
Normal Lung Appearance
